PROJECT S.W Jack Drilling

BUILDING OWNER S.W. Jack Drilling.
Jack Drive
Indiana, PA

AREA Twenty Thousand One Hundred Square Feet

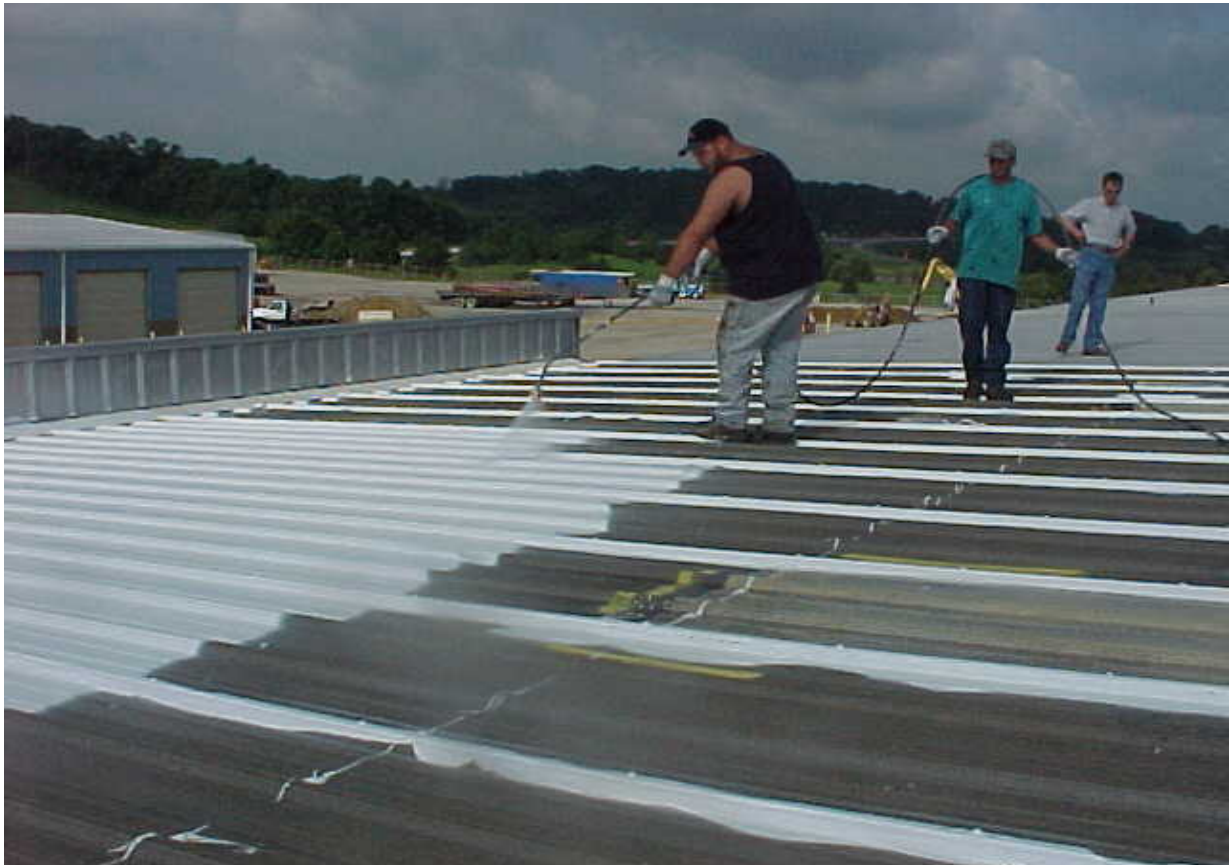
DESCRIPTION Periodic roof leaks were causing the fiberglass insulation directly under the metal panel roof to retain moisture for long periods of time. This moisture was then causing the metal roof panels to rot from the inside out at many fastener heads.

At each of these fastener heads, sheet metal blanks were sealed to the roof using Truco #7174 trowel grade rubberized sealant and polyester fabric to assure that future leakage problems were eliminated. The rubberized coating system was then installed before the 10 year manufacturers leakage warranty was issued.
