**PROJECT** Saint Pius X Roman Catholic Church- Mt. Pleasant, PA. 2001

**AREA** Six Thousand Six Hundred Sixty Square Feet

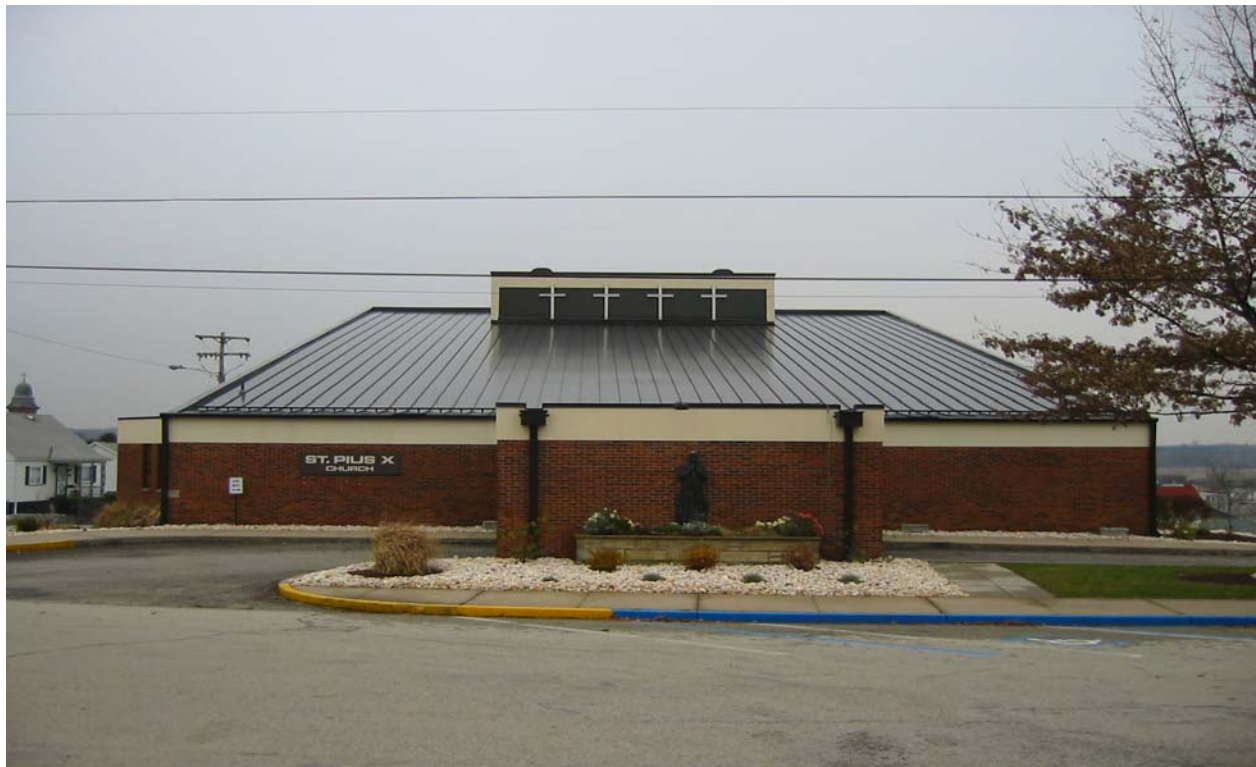
**DESCRIPTION** Two prematurely failed asphalt shingle roofs in less than twenty years convinced everyone involved that a different approach to waterproofing was needed. Factors contributing to roof failure were twofold: less than desirable pitch- 2.5/12 dropping to 1/12 at a pitch break five feet from the eaves edge, and a total lack of ventilation. Our solution: a new breathable deck- 3/4" plywood over 1" x 3" treated wood furring with air intake at the eaves and all upslope counter flashings vented for exhaust.

A 24-gauge double rolled standing seam panel was installed. Integrated gutters, coping cap, and counter flashings were custom fabricated in our sheet metal shop. How do you move 90 ft. plus panels from the ground to the roof? Elevate the front end of the roll former and let the machine do the work!
